Common Problems

- from the Activity Report of JICA expert

Name IKEDA Akira
Country Sri Lanka
Field Improvement of Water Treatment Technology & Coordination of Japanese Project
Duration From 6th JUNE2002 to 5th JUNE2004

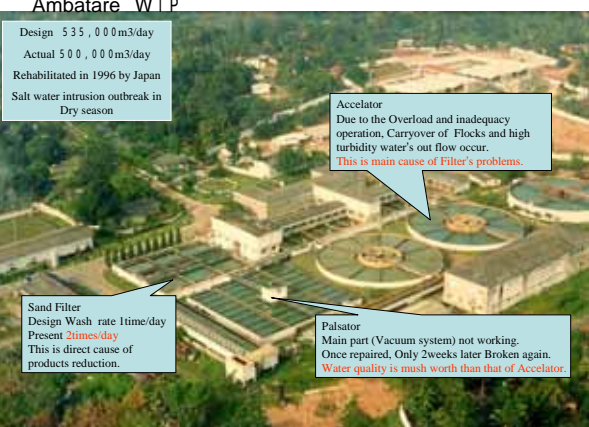
Ambatere WTP

Design 535,000m³/day
Actual 500,000m³/day
Rehabilitated in 1996 by Japan
Salt water intrusion outbreak in Dry season

Accelerator
Due to the Overload and inadequacy operation. Carryover of Flocks and high turbidity water's out flow occur.
This is main cause of Filter's problems.

Sand Filter
Design Wash rate 1time/day
Present 2times/day
This is direct cause of products reduction.

Palstar
Main part (Vacuum system) not working.
Once repaired, Only 2weeks later Broken again.
Water quality is much worse than that of Accelerator.

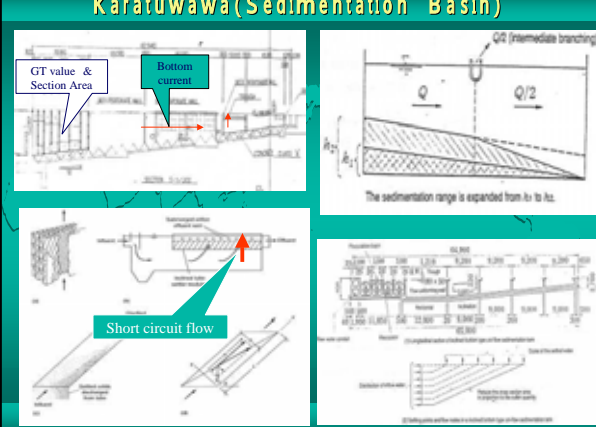
Karatuwawa (Sedimentation Basin)

Bottom current

The sedimentation range is expanded from 1m to 1.5m.

Short circuit flow
