Recent water quality incidents and a methemoglobinemia outbreak in infants due to inadequate plumbing of a university hospital's private water supply

ASAMI Mari, MIYOSHI Taro, MIURA Takayuki

Area on Water Management, Department of Environmental Health, National Institute of Public Health

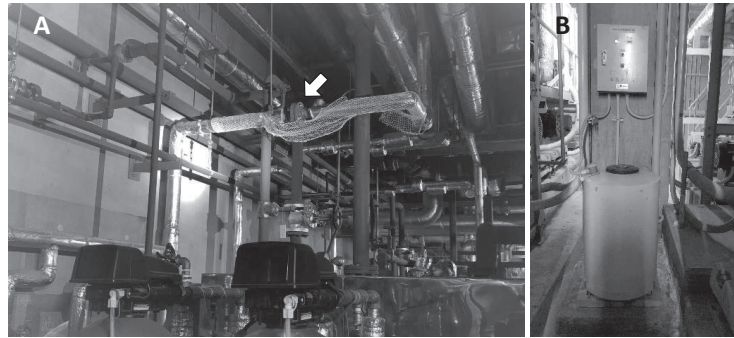
Investigation of the cause revealed that the water piping equipped in air conditioning system and the water piping used in the water supply system had been directly connected by a check valve with a simple structure (Figure 4 [15]) since the construction of the ward approximately 20 years ago. In the piping shown in Figure 5 [15], this connection is not capable of completely preventing backflow from the air-conditioning water piping to that of the water supply system (Figure 6 [15]). On the basis of the results of the investigation, the hospital disconnected the water piping for air conditioning from that for the water supply system as a measure to prevent recurrence. Afterwards, the hospital implemented intensive cleaning of the water supply system piping and confirmed that nitrite was no longer detected.

Figure 5 The water system in the hospital building. (A) The pipe connected to the air-conditioning system. The part where the check valve was installed is indicated with a white arrow. (B) An anticorrosion agent was injected from a tank with a pump, both of which were installed in the central machine room.

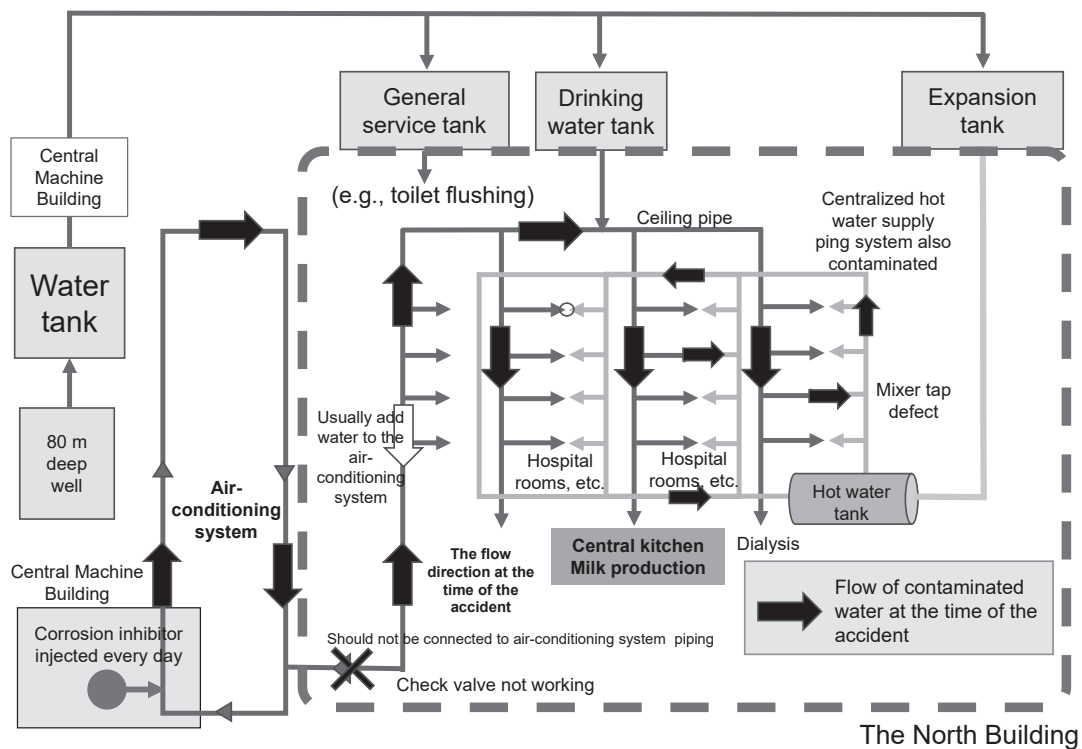
Figure 6 Schematic diagram of ward piping. Dashed lines indicate wards where accidents occurred. The authors added the contaminated water flow to the Gunma University press release on December 16, 2021 [14].
