Measures for recovery against seismic damage to wastewater systems

TANAKA Shuji

Director, Water Quality Control Department, National Institute for Land and Infrastructure Management, Ministry of Land, Infrastructure and Transport, Asahi 1, Tsukuba, Ibaraki 305-0804, Japan. tanaka-s92ta@nilim.go.jp

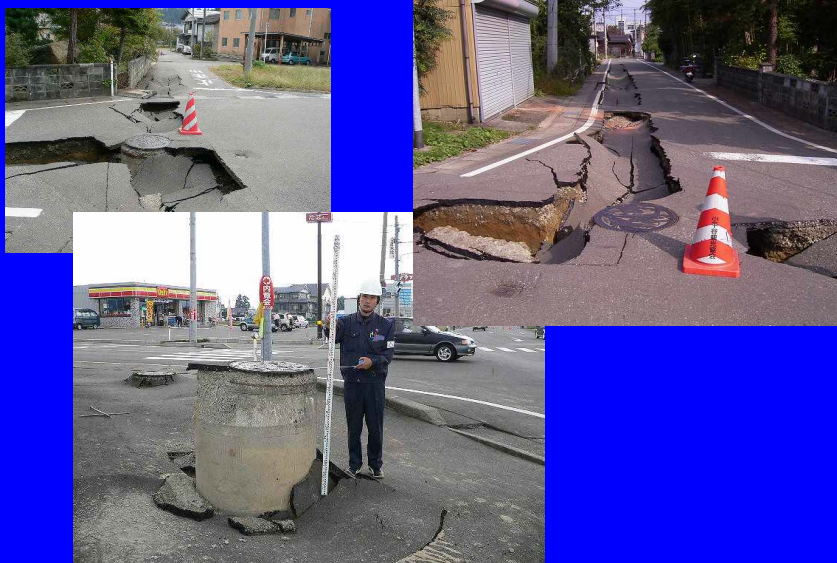
Typical damage types in Niigata-ken Chuetu EQ

Liquefaction of backfilled sand caused floating up of manholes and sewers

- Hyougo-ken Nanbu EQ:
 - Difficulty of finding of damages in sewers
 - Cracks caused by shaking of manholes and permanent strains of grounds
 - Relatively small damage-ratio: Ave. 1.7%, Max. 9.7%
- Niigata-ken Chuetu EQ:
 - Surfaced up of manholes and lifted up of sewers
 - Sinking of ground surfaces six months later
 - High damage-ratio: Ave. 4.6%, Max. 21.7%
